MARINE FIELD SERVICE BULLETIN

FSB Number	1319340169
FSB Title	DigiSTREAMER DUAZ GPS Week Rollover
Date	January 9, 2020
Originator	Sean Stanford
Product Group	DigiSTREAMER
Product Name	GPS INTERFACE UNIT DSTR
Product P/N	AS9000-3920

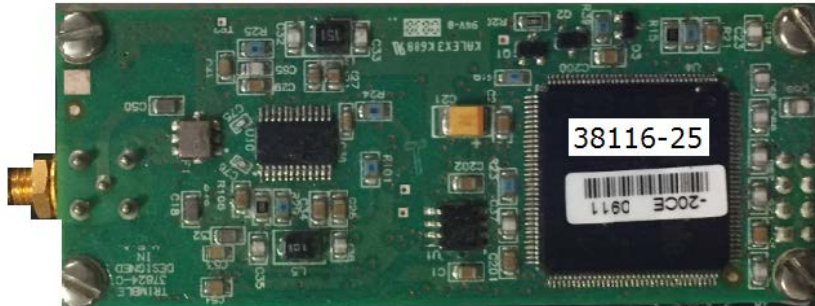
ION 1701-111, Trimble 38116-00

Old, obsolete Trimble Lassen SK II:

4. If the Nalecom NLC-SKII-CP2 GPS Module is installed, do nothing as the correct GPS Module is already installed. Reassemble the DUAZ chassis. If the Lassen SKII GPS Module is installed, it must be replaced with a configured Nalecom NLC-SKII-CP2 GPS Module. Continue to step 5.

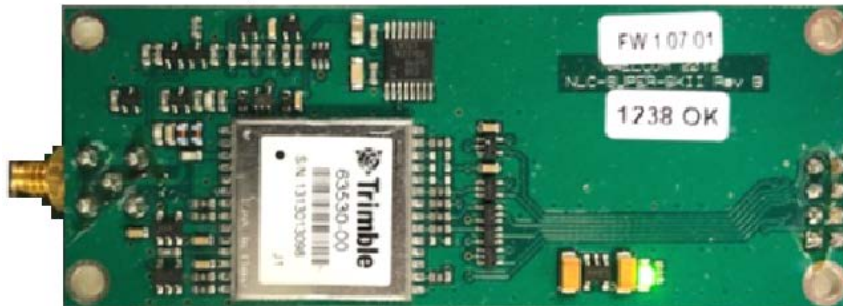
ION 1701-132, NAELCOM NLC-SKII-CP2

Newer NAELCOM NLC-SKII-CP2:
